Wet Scrubber Case Study 2

Metal Processing Manufacturer

Metal dust collection

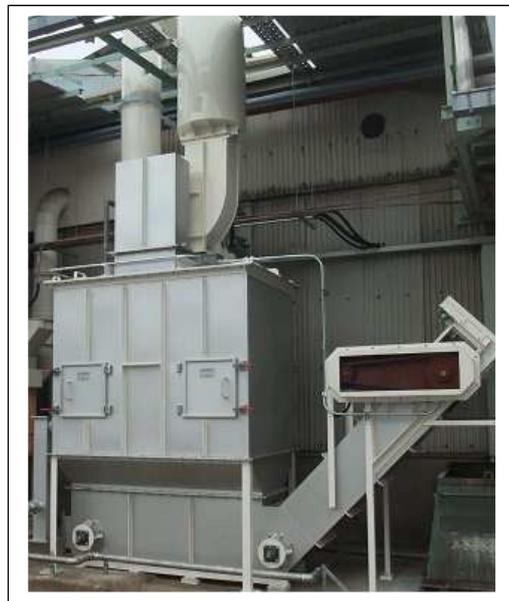
Model Name: Wet Scrubber

Model Type: WS-150-SC

Sludge Conveyor Type

Air Volume: 150 m³/min

Pressure loss: 1.3kPa
